Propeller modifications

Trailing edge adjustment for heavy running propellers

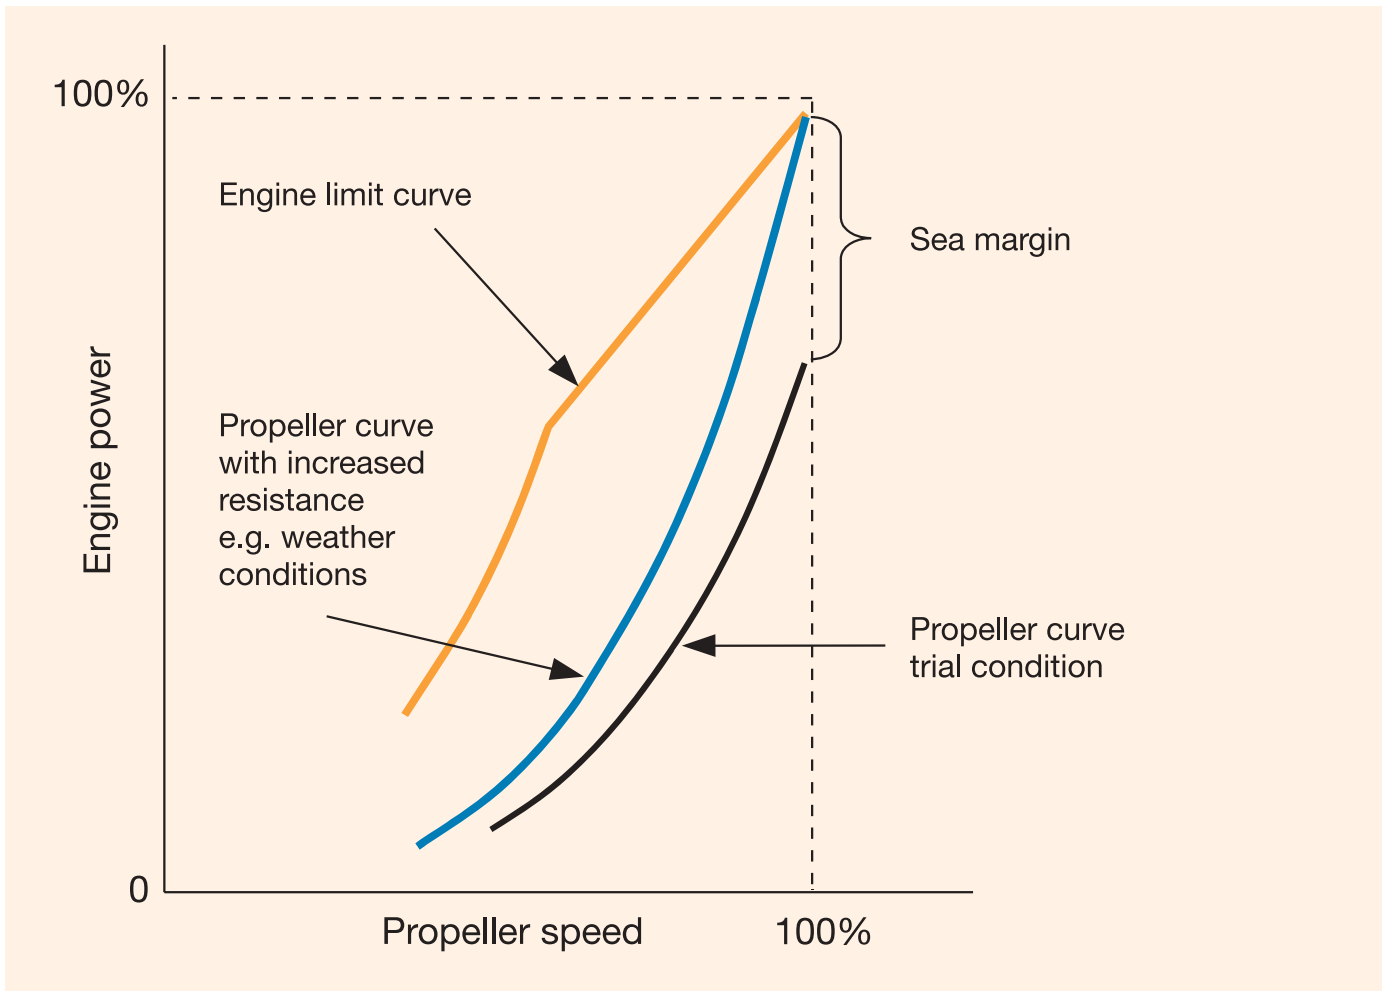
Fig. 1 The engine loading diagram in a regular situation.

Figure 1 shows the engine loading diagram for a regular situation. The propeller’s pitch is selected so that 85 % of the MCR power is generated at 100 % nominal shaft speed. This creates a sea margin to accommodate any increase in the ship’s resistance due to the weather. Full

power can be generated at full rpm in service conditions (including the sea margin).

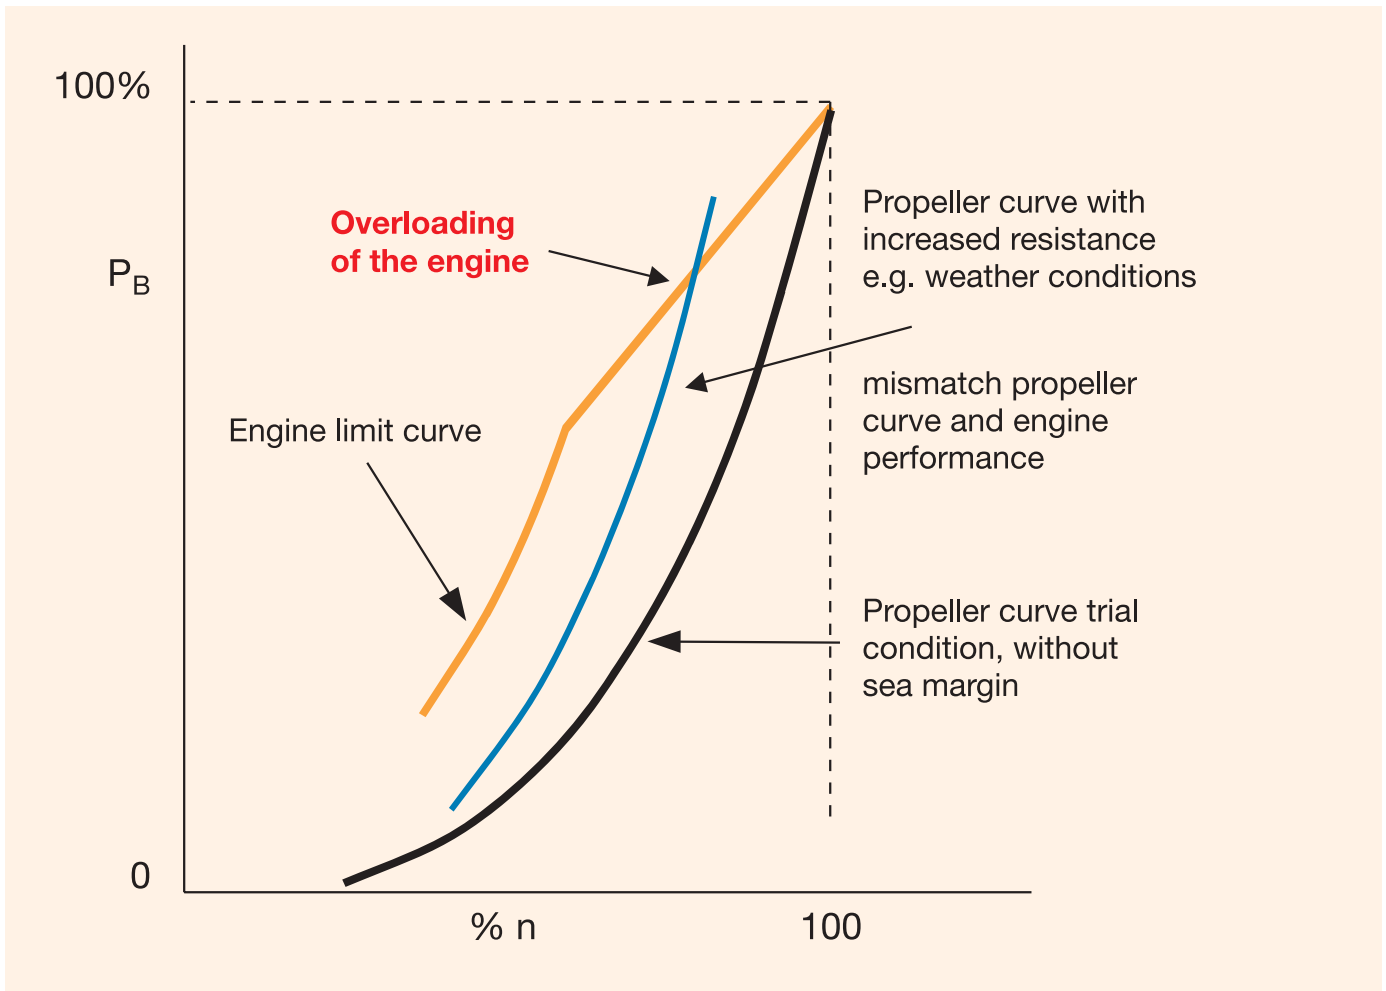
Fig. 2 The engine loading diagram for a heavy running propeller.

The engine loading diagram for a heavy running propeller is shown in Figure 2. For some reason, the propeller’s power absorption in trial conditions may show only a small or even a non-existent sea margin. If the ship’s resistance increases now, the engine will run in overload. At low propeller speeds, the power demand is larger than the engine can deliver; the propeller’s power curve crosses the engine load limit before the full power of the engine is reached.

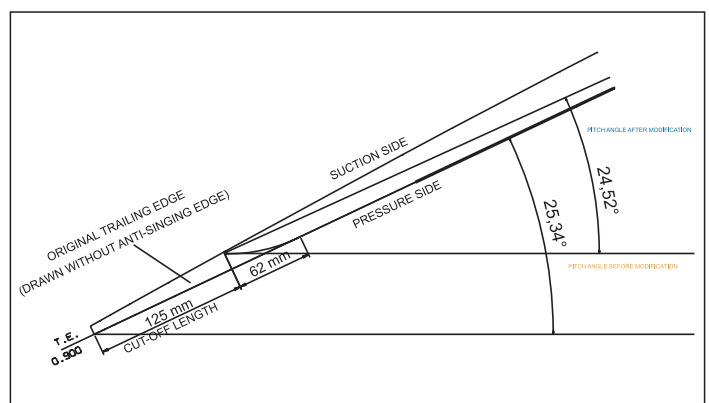
Fig. 3 A sketch of the modified trailing edge.

Figure 3 shows a sketch of the modified trailing edge. The pitch angle of a profile section is defined by the line through the nose and tail of the propeller section. The trailing edge is cut off at a certain length, in order to reprofile the section. The new tail is raised above the original nose-tail line, decreasing the pitch angle. A hydrodynamic profile is grinded to assure that the wing section works properly and to avoid erosive cavitation. In addition, an anti-singing edge is incorporated to avoid unwanted inboard noise. A major benefit of the trailing edge adjustment is that there is no loss in efficiency.

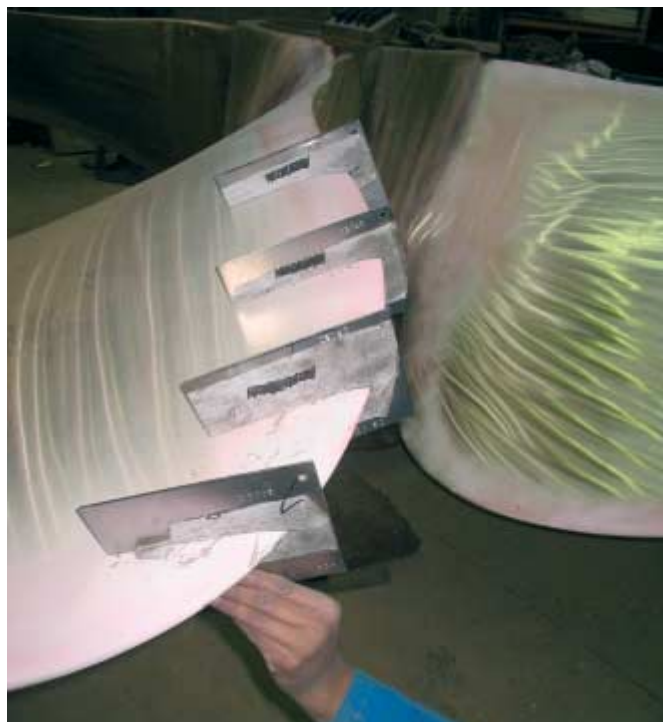
Checking modified trailing edge profile section by means of templates.

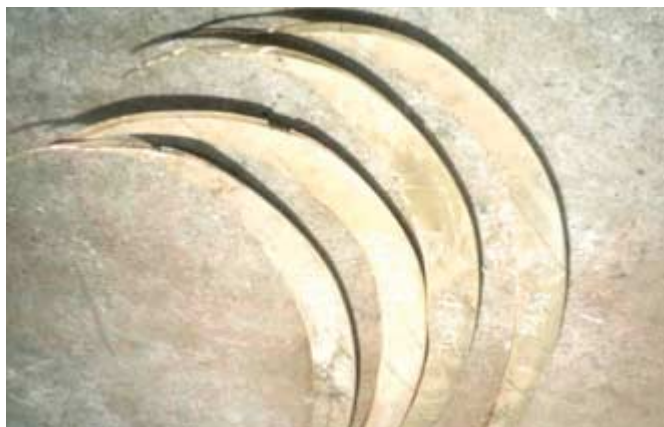
Equal pieces of propeller material are cut off.

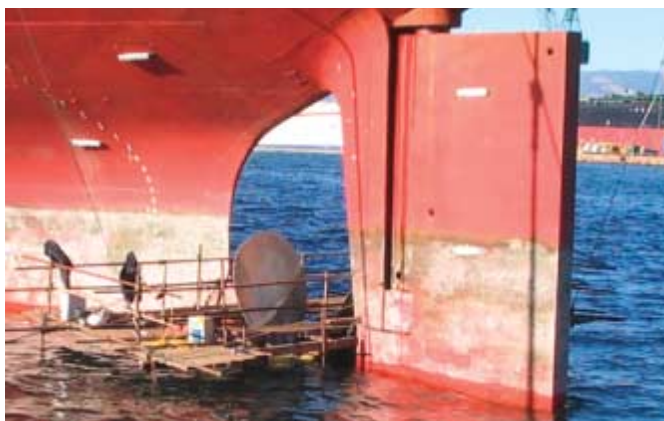
Trailing edge adjustment at pier side.

The propeller can be modified while the propeller is fitted on the shaft, there is no need to demount the propeller. This means the cutting and grinding can be carried out at ship repair yards, in dry dock or at the pier side at trimmed position. The work can even be carried out offshore, depending on the weather conditions. We have a global service network of engineers trained to perform propeller modifications in order to serve locally and keep the costs as low as possible.
