WÄRTSILÄ

RECONDITIONING SERVICES

# WÄRTSILÄ RECONDITIONING SERVICES

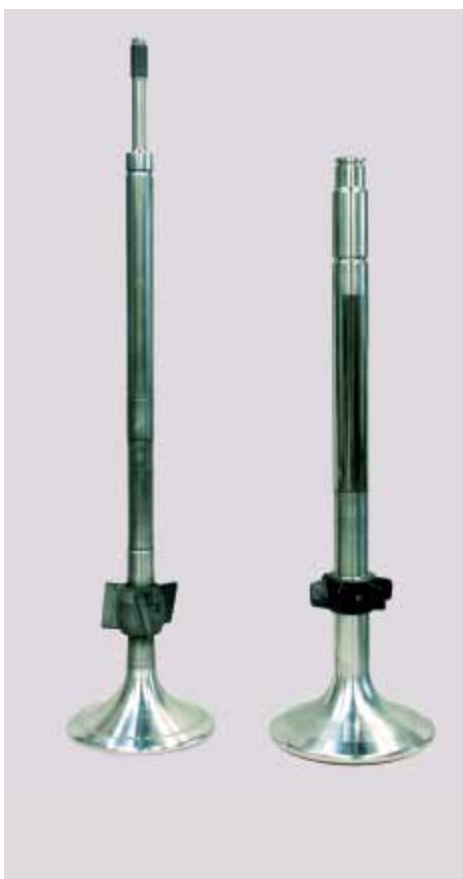
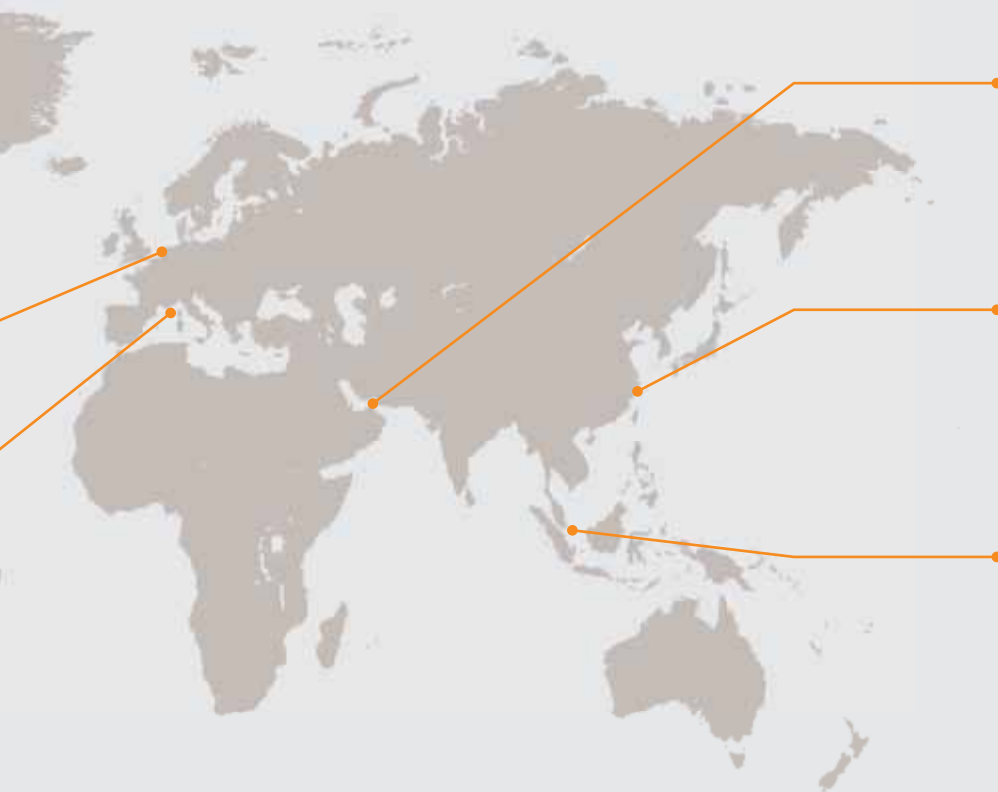
Wärtsilä procedures include building up and re-profiling the exhaust valve to the original manufacturer templates. The combustion face and the upper face of the valve disc are remanufactured using advanced robotic welding equipment. The re-stelliting of the seating surface is carried out with Plasma Transfer Arc process, which ensures a high quality weld with minimum dilution of the base material. The valve stem is carefully measured and if it is worn, it is reconditioned using the HVOF spraying process. Wear incurred by chromium plated stems can be rectified by removing the existing chromium layer and replacing it with an HVOF cermet coating.

Special and controlled Wärtsilä procedures are also applied when reconditioning exhaust valve seats for all types of engines. The existing stellite layer is removed, the substrate is then built up, and this is followed by re-stelliting, machining and grinding the valve seat back to original dimensions.

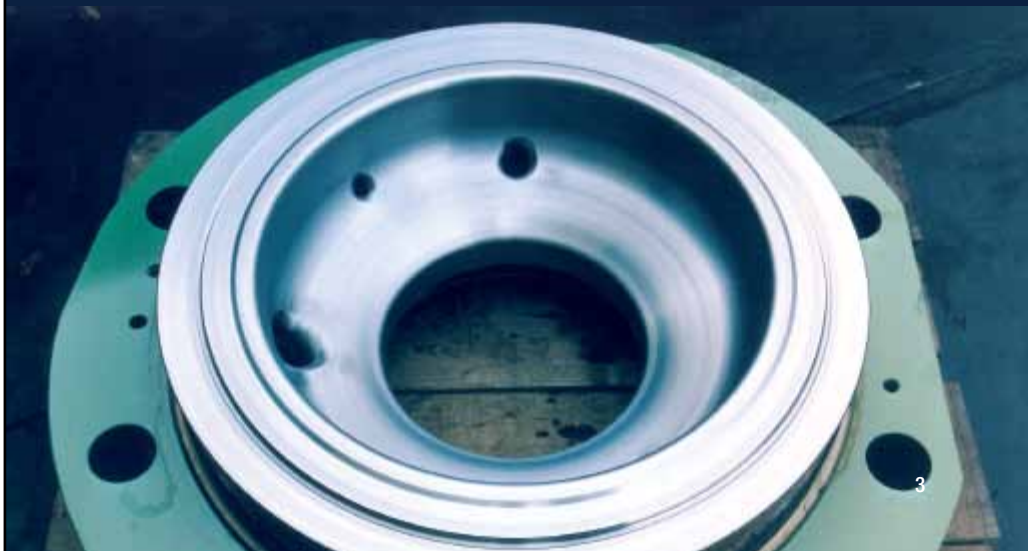
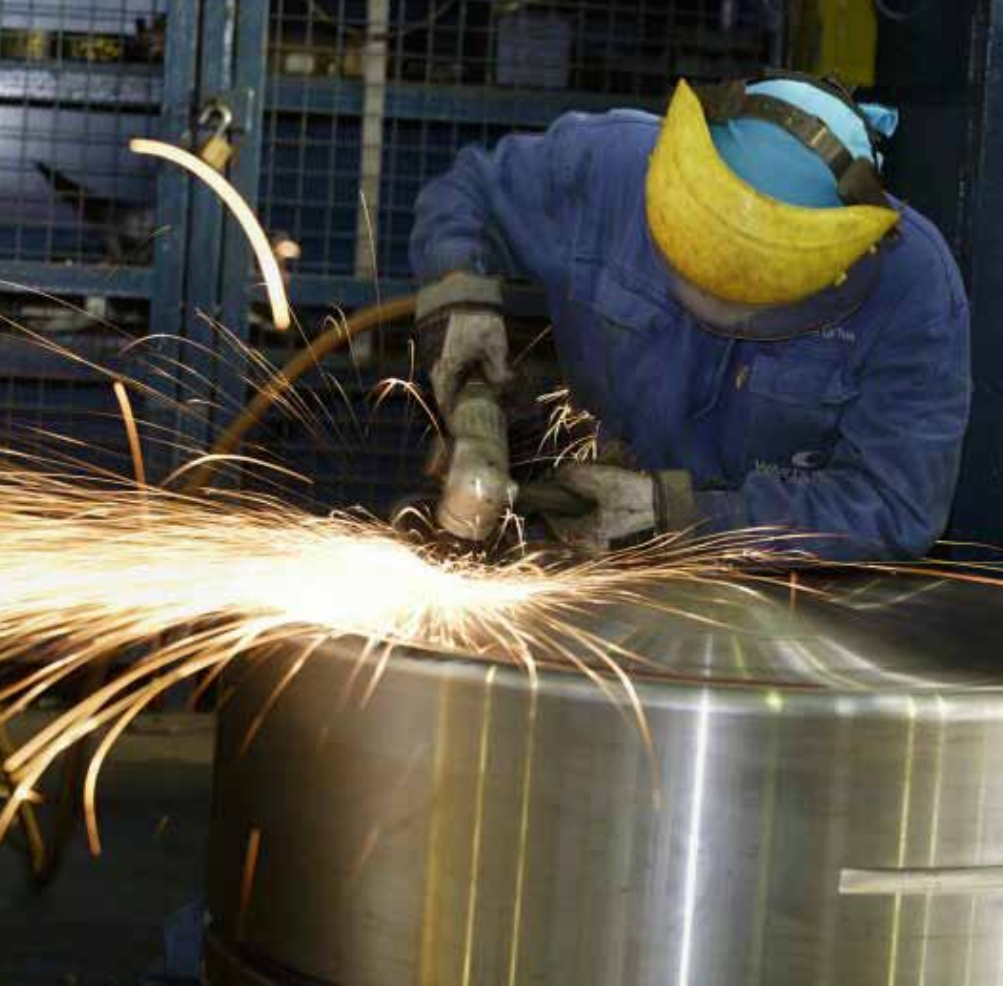
from forged steel with cooling bores. Failure in service can be caused by a range of problems including erosion and corrosion in air start and safety valve bores, erosion in the area adjacent to the injectors, leakage from sealing rings, cracking from the cooling bores, and fretting of the sealing faces and o-ring grooves.

Standard Wärtsilä repair procedures on B&W cylinder covers include replacing the cooling rings.

Reconditioning of Sulzer cylinder covers includes a number of modifications which are approved by the OEM.

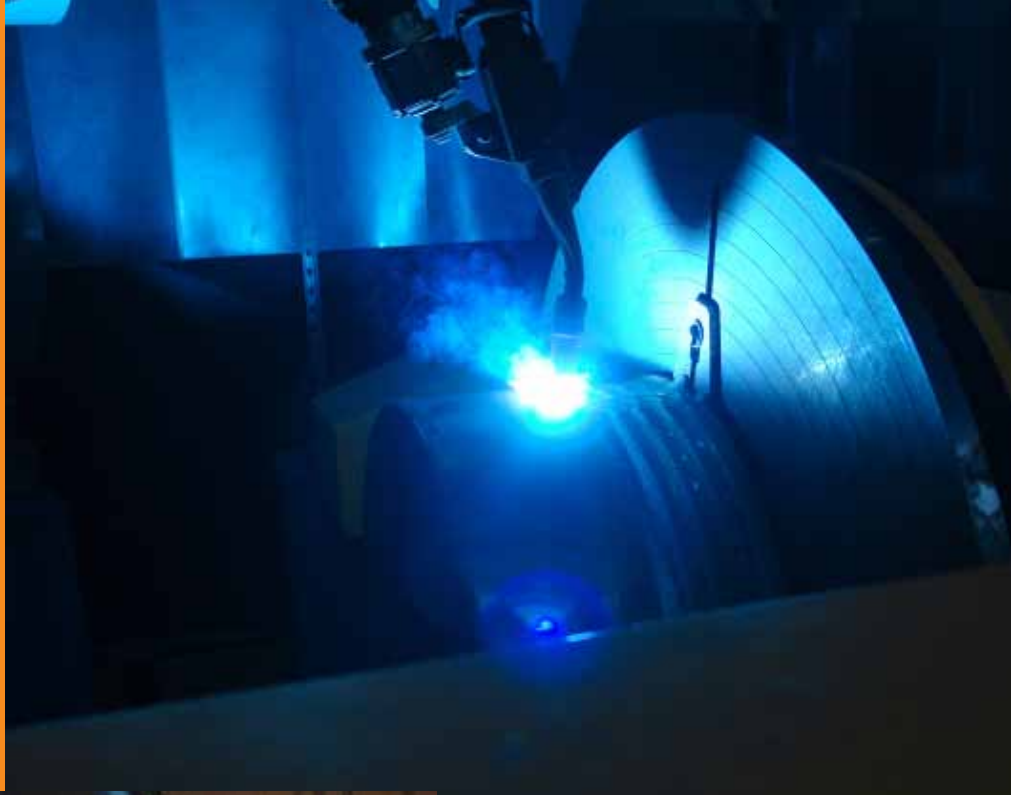
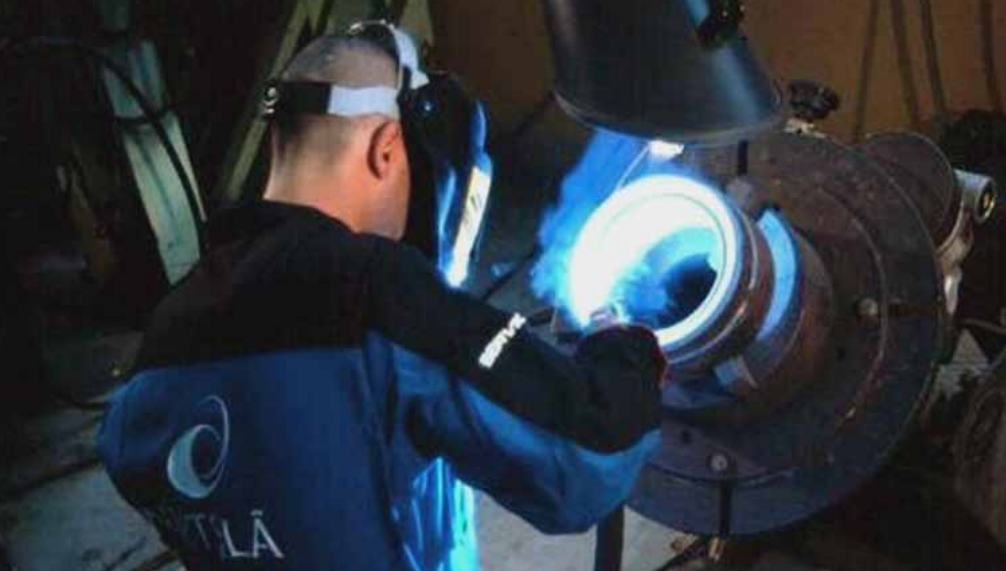
A frequently found wear pattern on connecting rods is excessive ovality of the big-end bore. In the long run, oval shaped big-end bores may cause crankpin bearing failures, resulting in crankshaft damage.

If no cracks are found during inspection, the following repair procedure is applied. Serrations on the rod and cap side are skimmed on a CNC milling machine, which will reduce the diameter in the vertical direction at the split. The separate parts are fitted together again and the mating faces are checked with blue paste, bolts are tightened in accordance with the engine maker's instructions, and the big-end bore is machined to its original dimensions. The results of final crack detection and connecting rod geometry are then recorded. The connecting rod is protected against corrosion and made ready for shipment.

If cracks are found in the serration area, the connecting rod will be reconditioned completely, as per Wärtsilä procedures. The cracked serration is machined off completely, until the cracks have disappeared. The machined connecting rod is preheated in the oven. Having reached the required temperature, the machined area is rebuilt with certified Wärtsilä high quality alloys, following a controlled and strict welding procedure.
